# 2022 Servicing the Water Wall

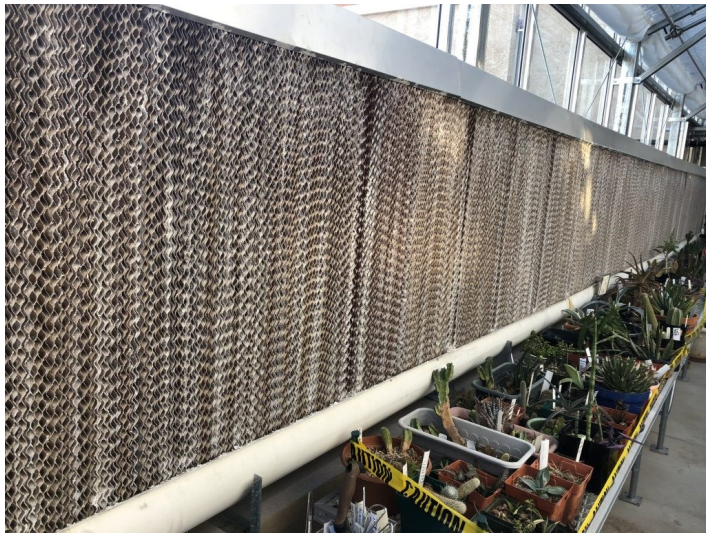
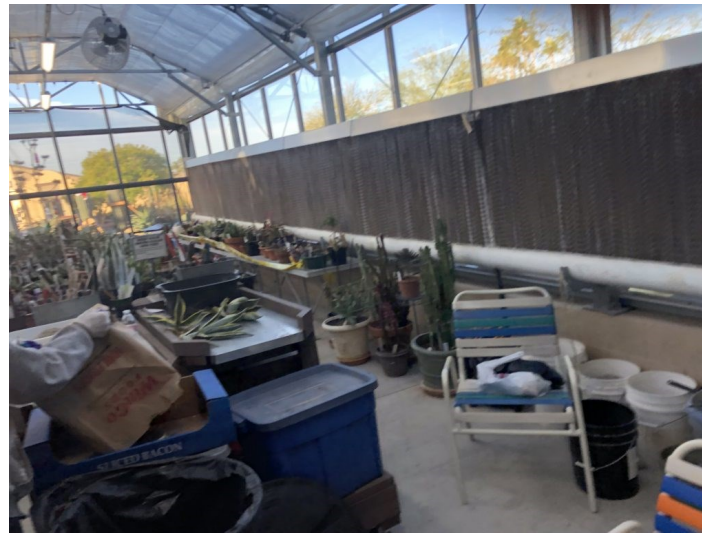
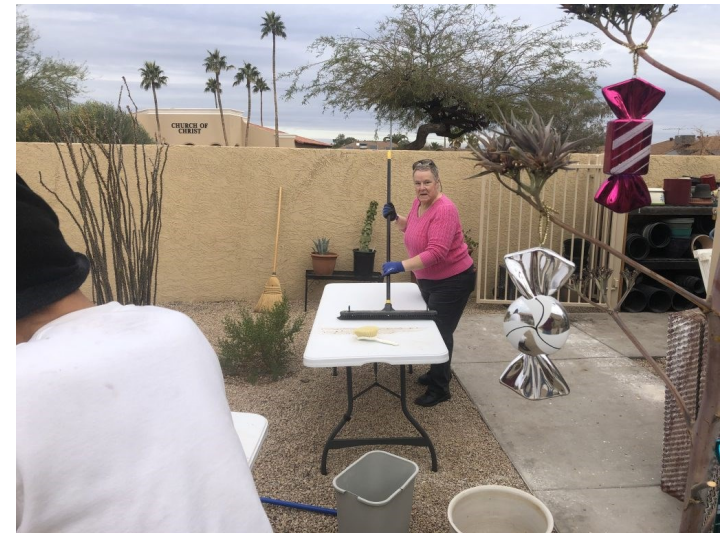
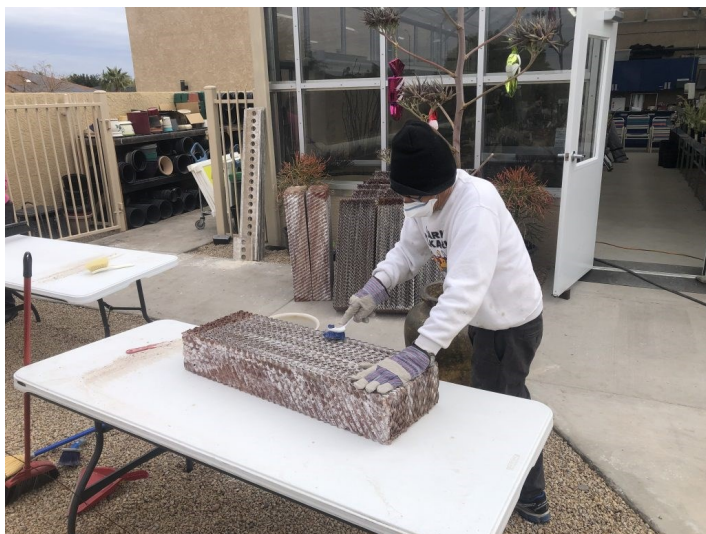
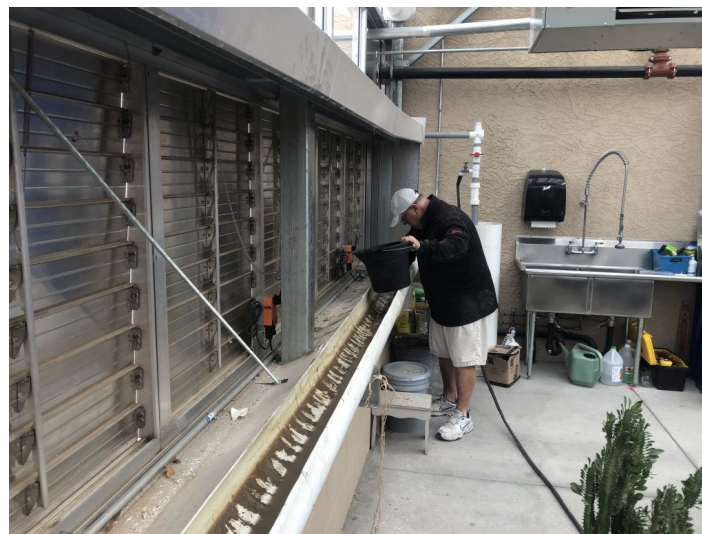
Lots of mineral deposits were shaken off the panels before carefully brushing the brittle units to get rid of as much of the white powder as possible.

The metal drainage pans required more elbow grease as the minerals had to be scrapped and chipped off.

The big surprise was in the large return pipe at the bottom of the unit. It was obvious that the “Arizona dust” was being drawn in and mixed with the water running over the cardboard panels when the system was in operation. This resulted in a thick layer of mud in the bottom of the pipe.

After Mike Anderson removed the mud and drained the storage tank, he installed a new pump as the first pump had already burned out since the system was running up to 22 hours in the hot summer months.

Finally, the bottom pans and cardboard panels were reinstalled, the tank filled with fresh water, and the cooling system was tested. This will probably become a twice-a-year process.
